## STRUCTURAL PERFORMANCE TEST REPORT

CUSTOM DECORATIVE MOULDING  
12136 Sussex Highway  
Greenwood, Delaware 19950

Report No: 53086.01-119-19  
Test Date: 08/23/04  
Through: 09/02/04  
Report Date: 02/21/04

**Product:** Wood Reinforced Polyurethane Foam Porch Post

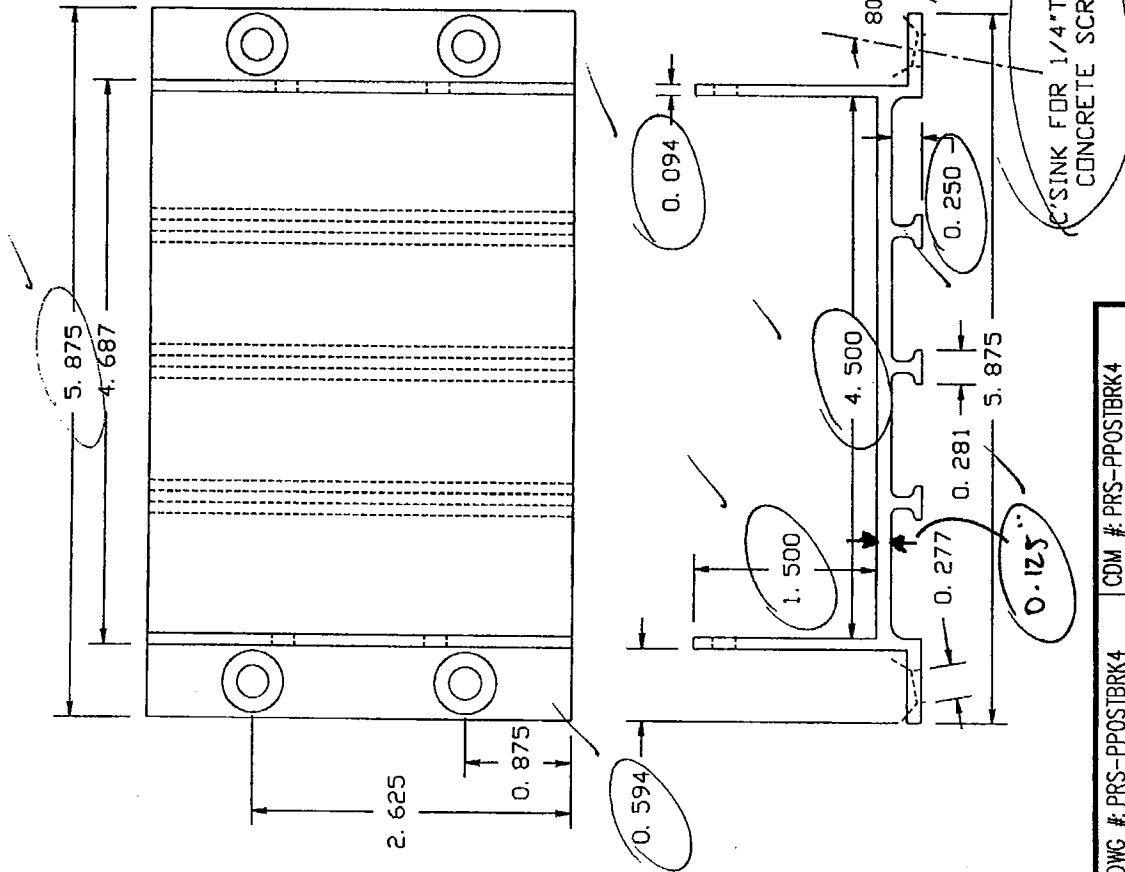
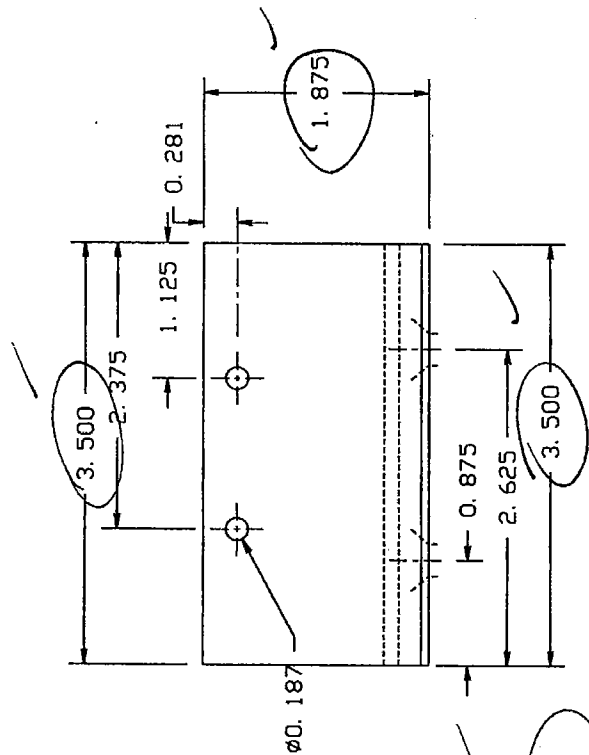
DWG # PRS-PPOSTBRK4		CDM # PRS-PPOSTBRK4	
PROJECT: BRACKET FOR 4-1/2" PORCH POST		INV #:	
SCALE: 8" = 1'	DATE: 06-02-2004	REVISIONS	INITIALS
DRAWN BY: Craig H.			
CHECKED BY:			
MASTER FINISH DATE:			
NOTE:

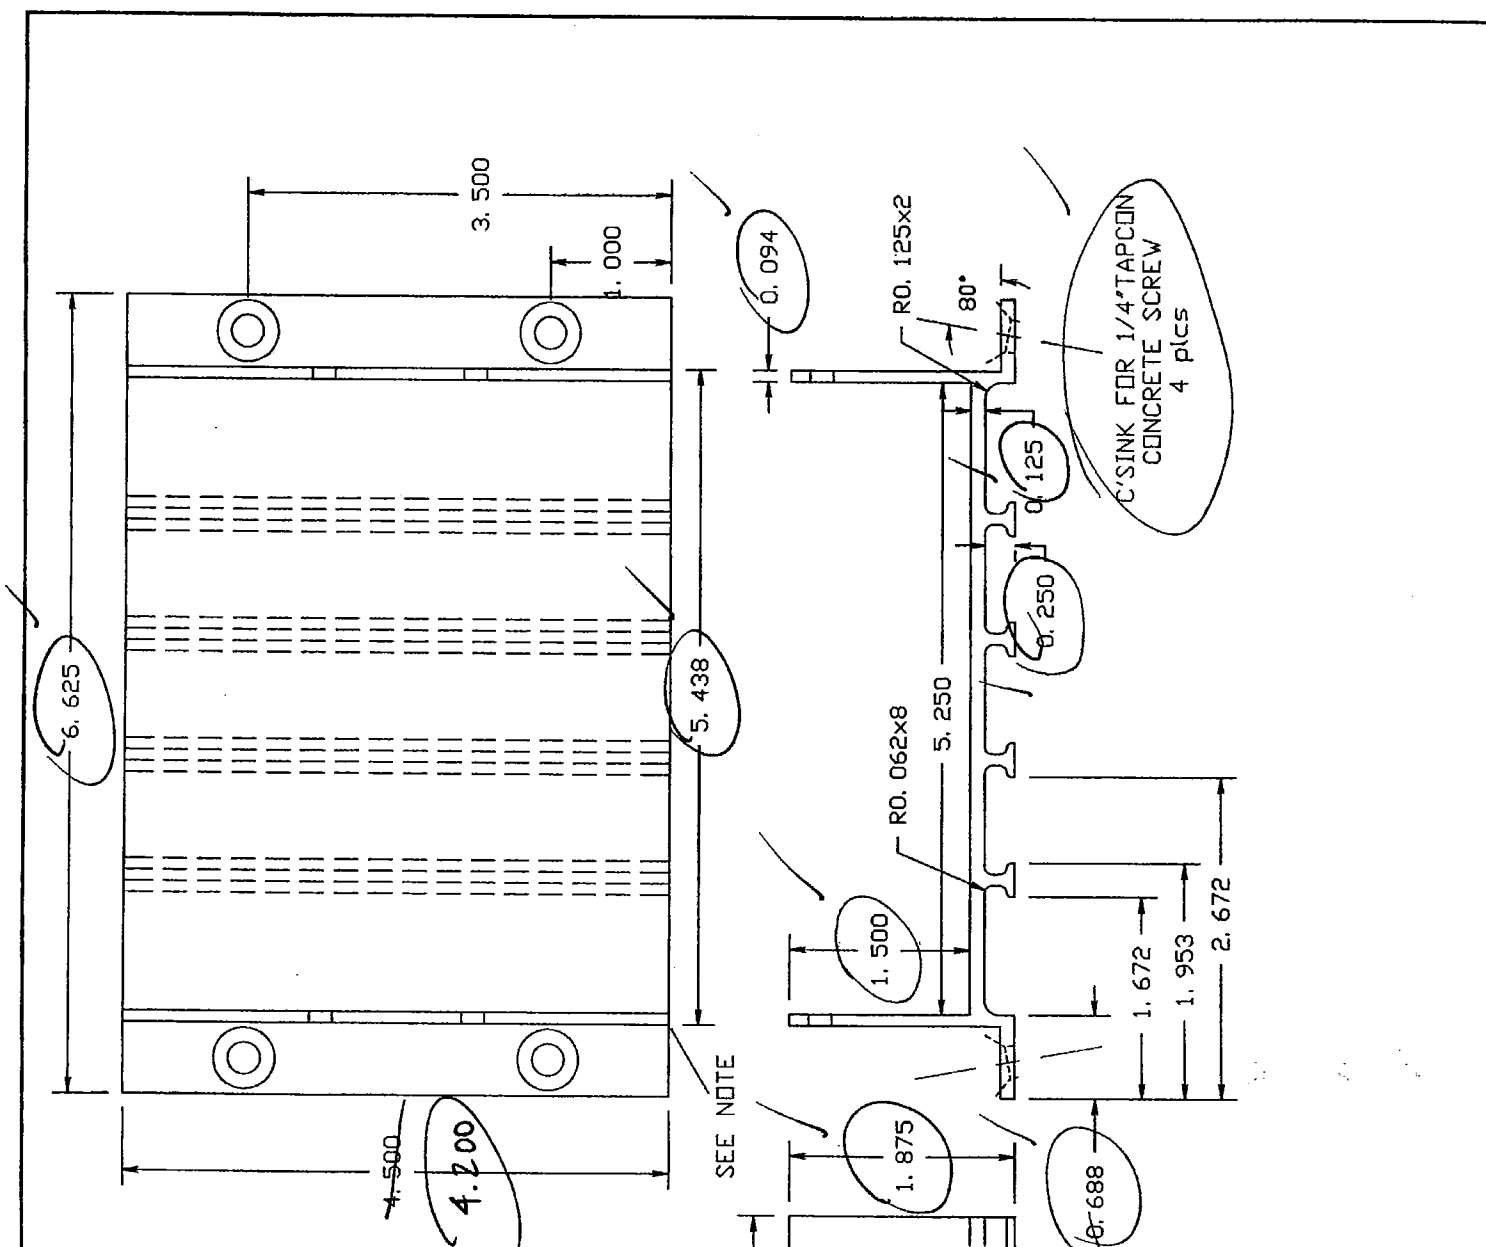
DWG # PRS-PPSTBRK5	CDM # PRS-PPSTBRKT5
	INV # 549
PROJECT: BRACKET FOR 5-1/4" PORCH POST	
SCALE: 8"=1'	DATE: 06-02-2004
DRAWN BY: Craig H.	REVISED INITIALS
CHECKED BY:	
MASTER FINISH DATE:	
NOTE:
