STRUCTURAL PERFORMANCE TEST REPORT

CUSTOM DECORATIVE MOULDING
12136 Sussex Highway
Greenwood, Delaware 19950

Product: Wood Reinforced Polyurethane Foam Porch Post

Type: 8 ft. Long 4-1/2" by 4-1/2" Porch Post
9 ft. Long 5-1/4" by 5-1/4" Porch Post

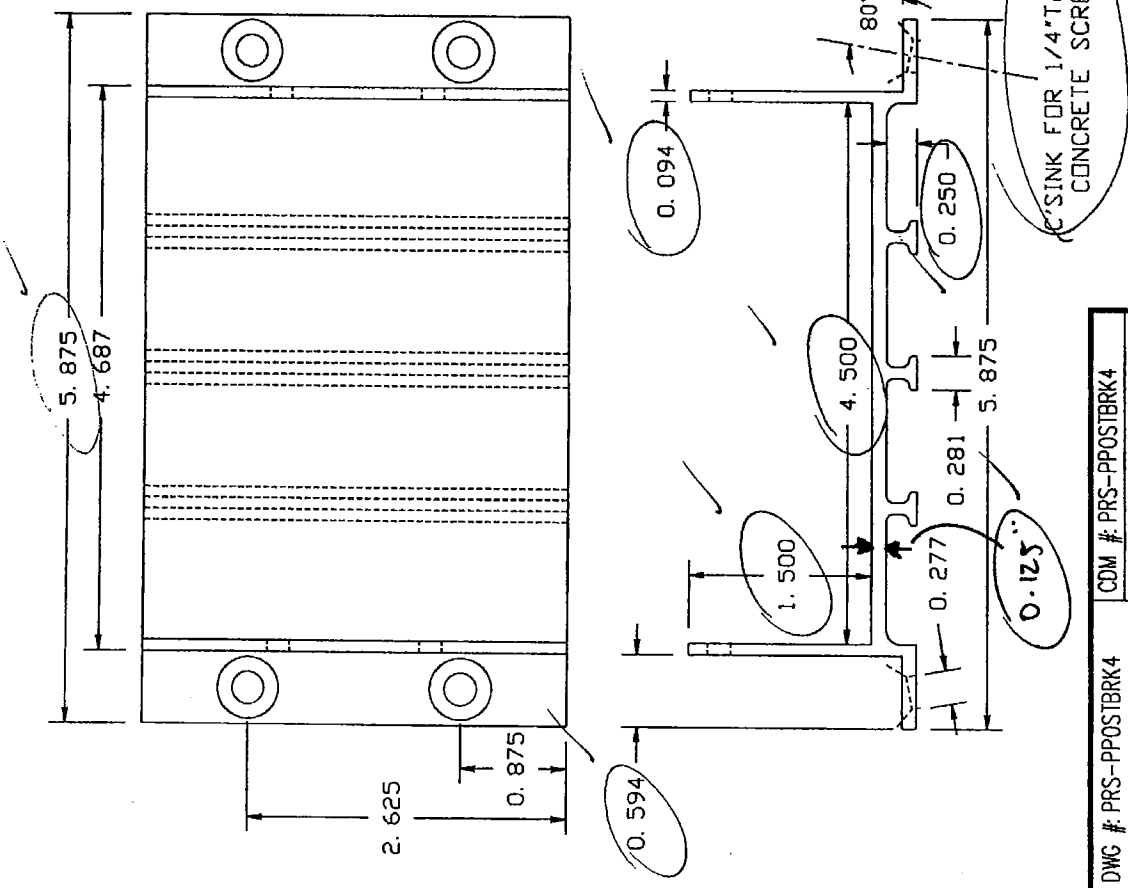
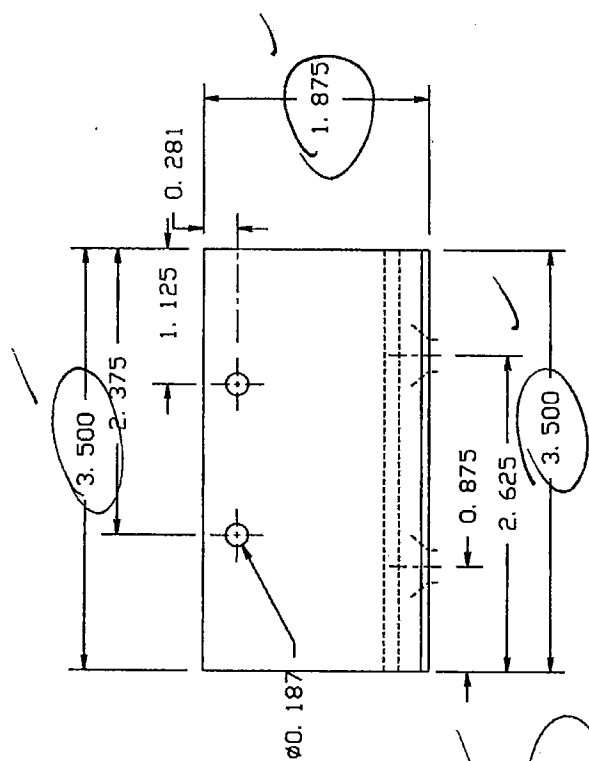
| DWG # PRS-PPOSTBRK4 | | CDM # PRS-PPOSTBRK4 | |

| PROJECT: BRACKET FOR 4-1/2" PORCH POST | | INV #: | |

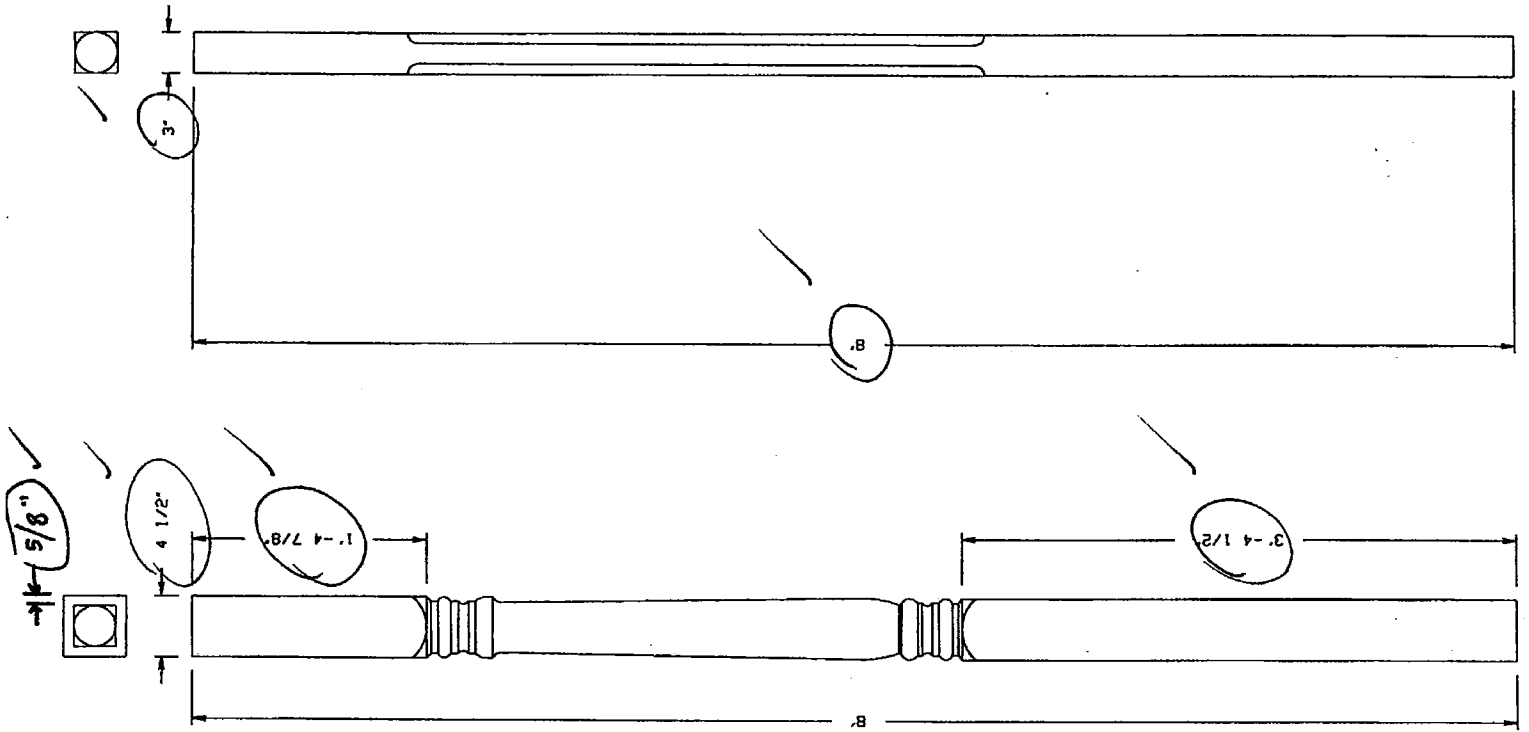
5 1/4" PORCH POST

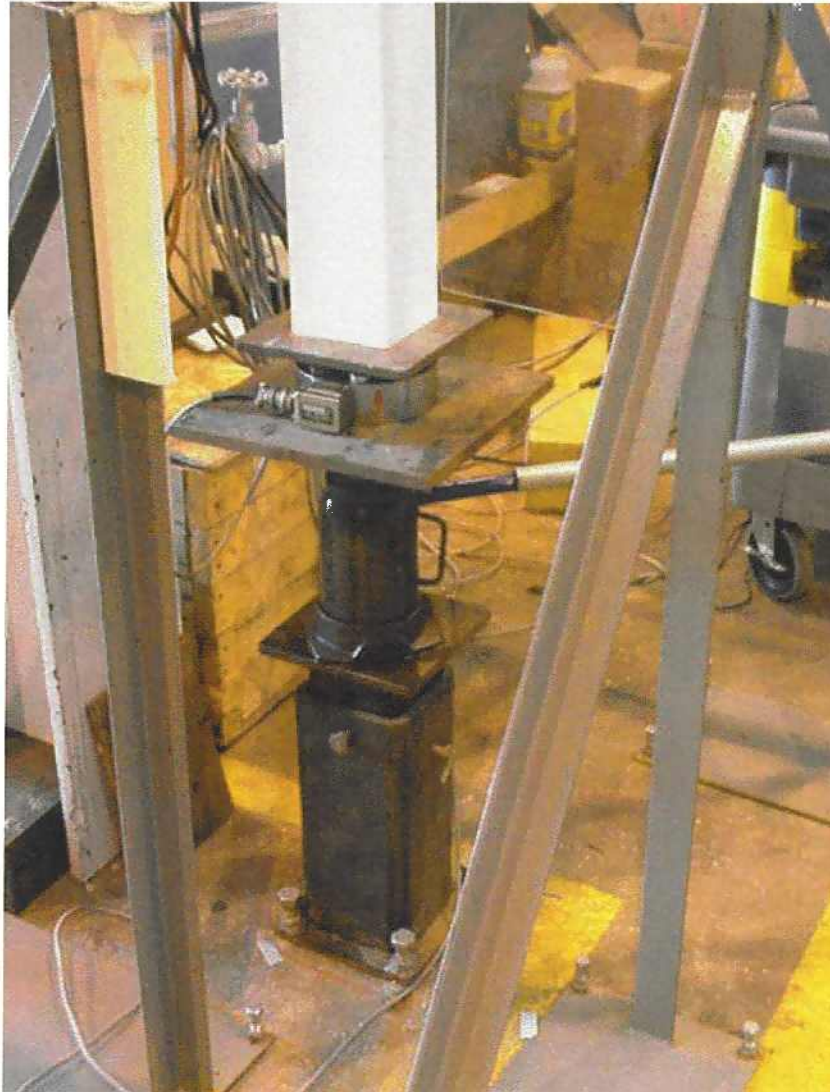
Photo No. 1
Column Base with Hydraulic Jack and Load Cell

Equipment: The axial load test fixture consisted of a flat rigid steel support at the top. The bottom consisted of a hydraulic jack positioned on a leveling fixture, fitted with a flat steel bearing plate and a 50,000 pound load cell. Test duration and deflection were recorded throughout the test.

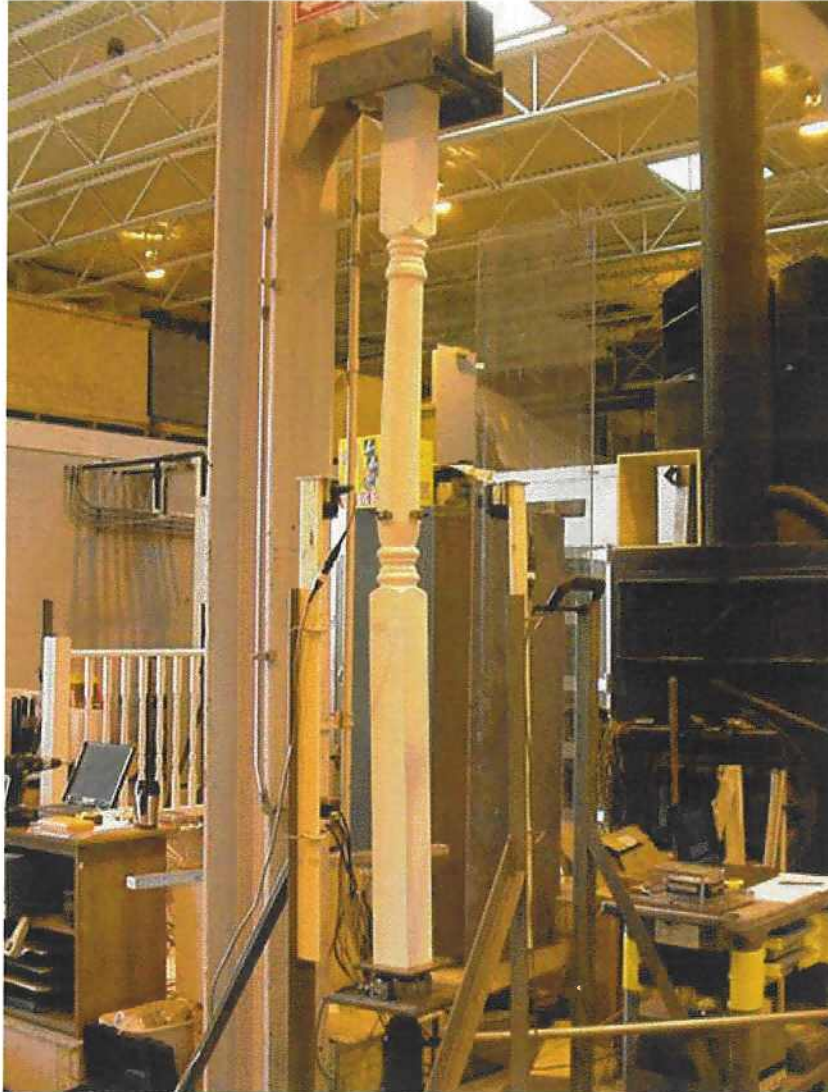
Photo No. 2
Axial Load Test Set-Up

Axial Load Test: The posts were installed into the compression fixture. The columns were plumbed with a "PLS-5" laser plumbing device, while applying a minimal preload to hold the specimen in place. Two electronic linear transducers were positioned perpendicular to the midpoints of two adjacent sides of the columns, to measure lateral displacements about the x- and y-axes of the column.

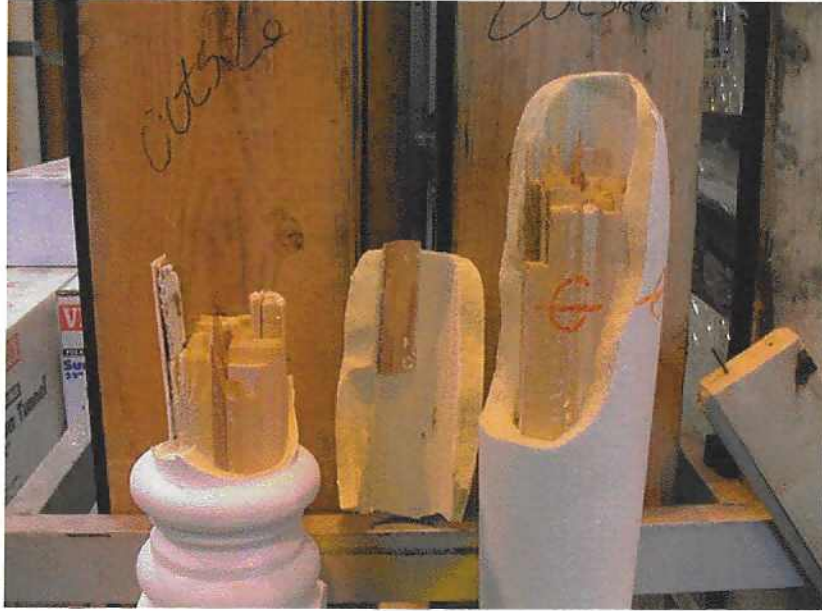
Photo No. 3
Axial Load Test Typical Failure of Specimen (5-1/4" by 5-1/4" Porch Post)

| Specimen No. | Ultimate Load (lbs) | Percent Deviation From Average |
|---|---|---|
| 1 | 27500 | 0.6% |
| 2 | 28200 | 1.9% |
| 3 | 27300 | 1.3% |

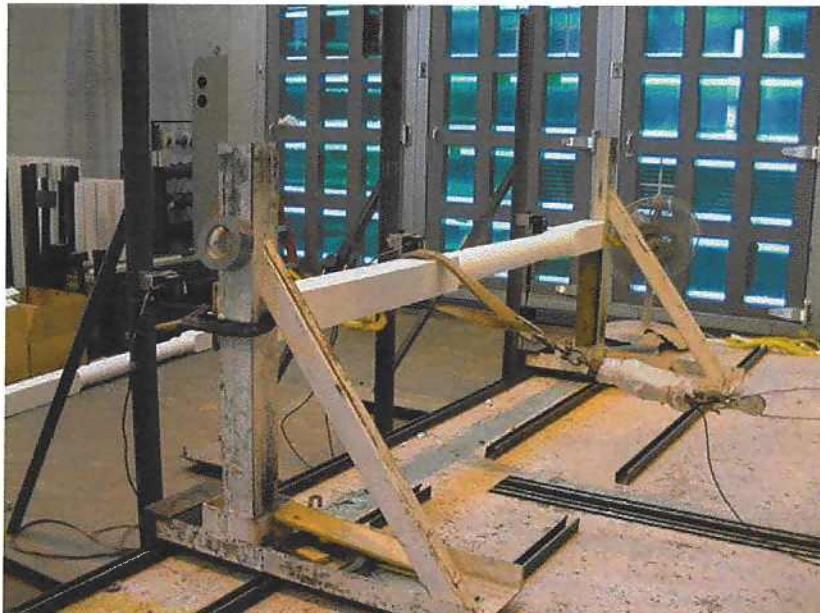
Photo No. 4
Lateral Load Test Setup

For the lateral load tests, the columns were tested in a self-contained structural frame. The specimen is loaded using an electric winch mounted to a rigid steel test frame. High strength cables and nylon lifting straps are used to impose test loads on the specimen. Applied load is measured using an electronic load cell located in-line within the loading system. Deflections are measured to the nearest 0.01" using electronic linear transducers.

Lateral Load Test: Both test specimens were tested by directly securing the ends of the columns into a rigid steel test frame. Transducers mounted to an independent reference frame are located to record movement of reference points on the columns (ends and mid-point) to determine net component deflections.

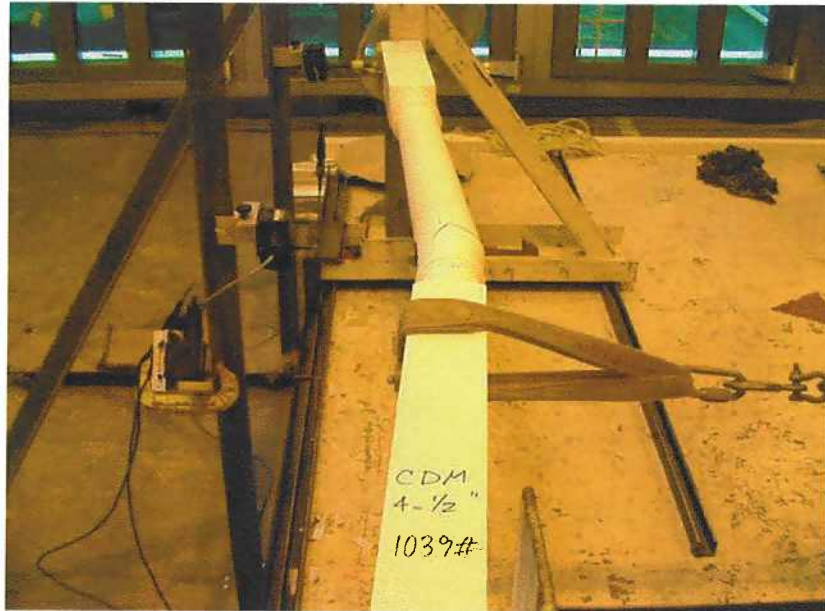
Photo No. 5
Lateral Load Test
Typical Failure of Specimen (4-1/2" x 4-1/2" Porch Post)

| Specimen No. | Ultimate Load (lbs) |
| 1 - M | 1421 |
| 2 - A | 1039 |
| 3 - M | 1461 |

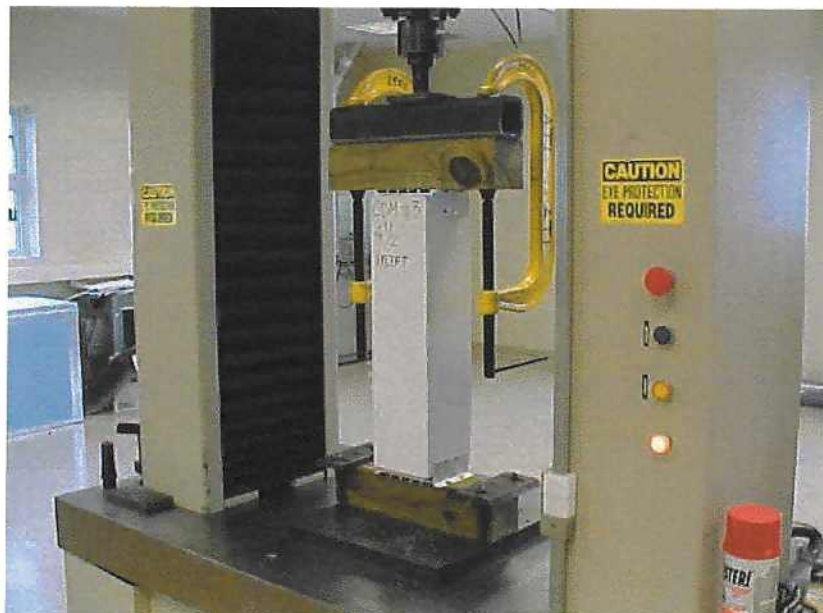
Photo No. 6
4-1/2" by 4-1/2" Porch Post Uplift Strength Test Setup

Uplift Load Test: The testing machine was fitted with 4 x 4 pressure treated SYP wood posts at the top and bottom to accommodate anchorage of the column brackets. The top 4 x 4 wood post was attached to the test machine with a swivel mechanism and the bottom 4 x 4 wood post was attached rigidly to the test machine. The swivel compensated for any inconsistencies in the squareness and plumb of the specimens. Each end bracket was secured to the 4 x 4 wood posts with four #12 by 2" Robertson head screws. Tests were run at a cross-head speed of 0.125 in./min. and all tests were conducted at lab ambient temperature (68°F ±4°F). Reference photographs in Appendix B for test setups.

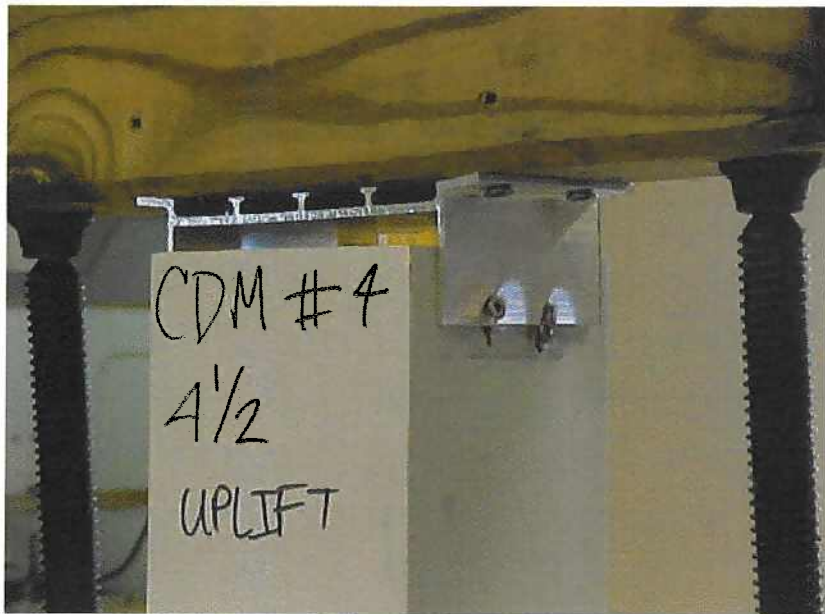
Photo No. 7
4-1/2" by 4-1/2" Porch Post Bracket Failure

| Specimen No, | Ultimate Load (lbs) | % Deviation From Average | Failure Mode |
|---|---|---|---|
| 1 | 2987 | 10% | Bracket Failure |
| 3 | 4900 | 32% | Bracket Failure |

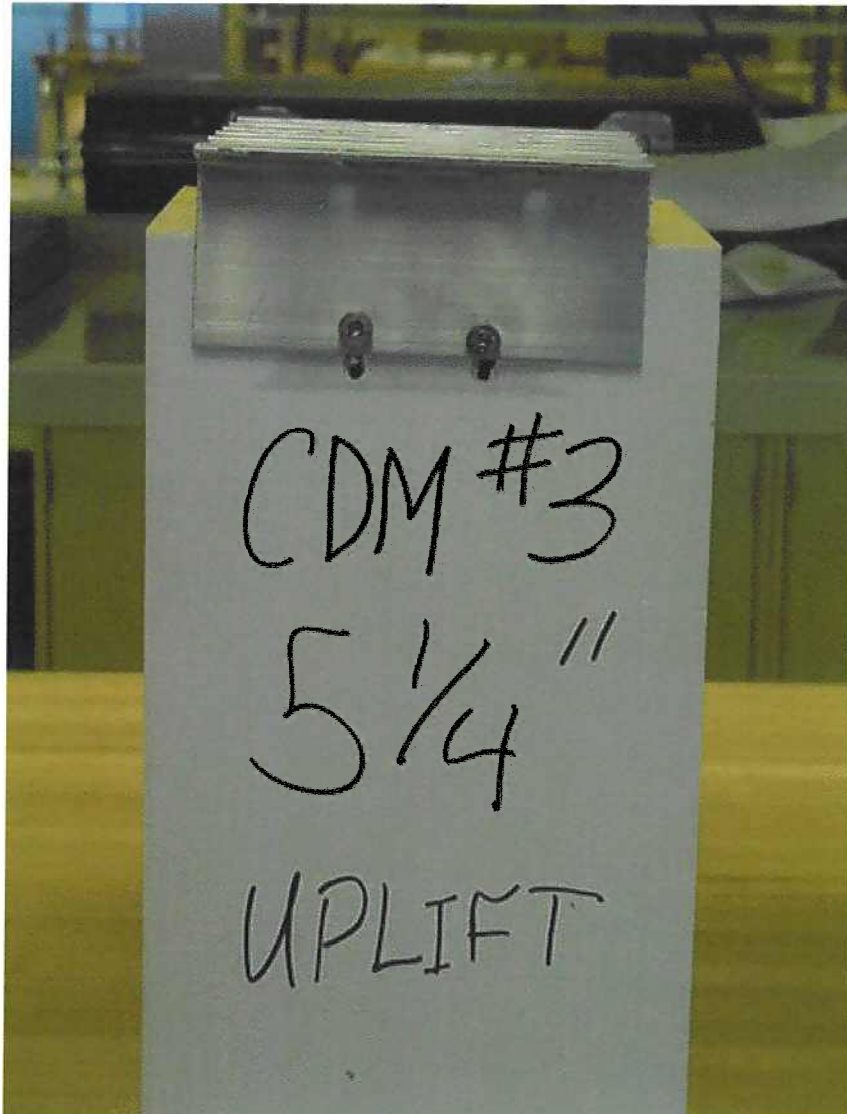
Photo No. 8
5-1/4" by 5-1/4" Porch Post Screw/Porch Post Failure

| Specimen No, | Ultimate Load (lbs) | % Deviation From Average | Failure Mode |
|---|---|---|---|
| 2 | 2517 | 10% | Screw/Porch Post Failure |
| 3 | 1689 | 26% | Screw/Porch Post Failure |

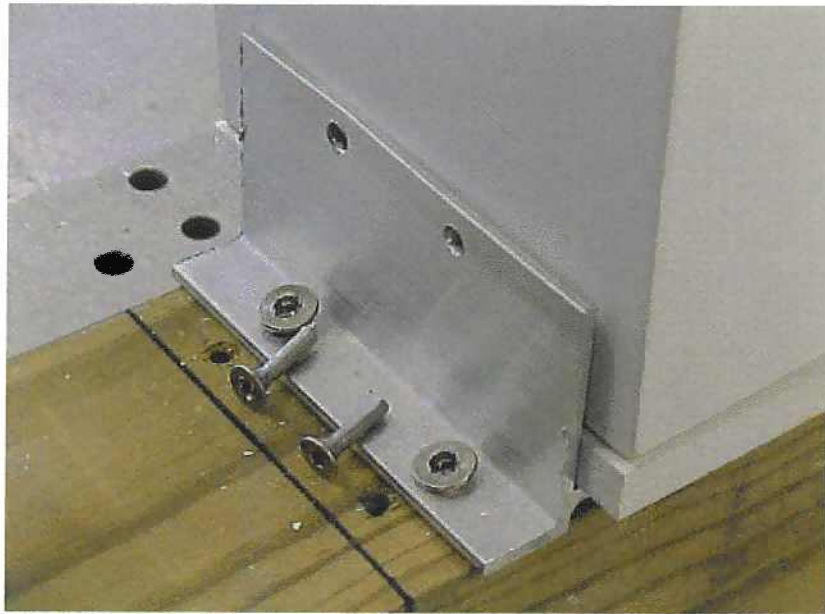
Photo No. 9
4-1/2" by 4-1/2" Porch Post Shear Failure of Screws

| Specimen No, | Ultimate Load (lbs) | % Deviation From Average | Failure Mode |
|---|---|---|---|
| 2 | 2124 | 36% | Shear Failure of Screws |
